Mangaroa River Flood Hazard Assessment

EROSION HAZARD REPORT

GW/FP-G-06/64

- Revision A
- 29 May 2006

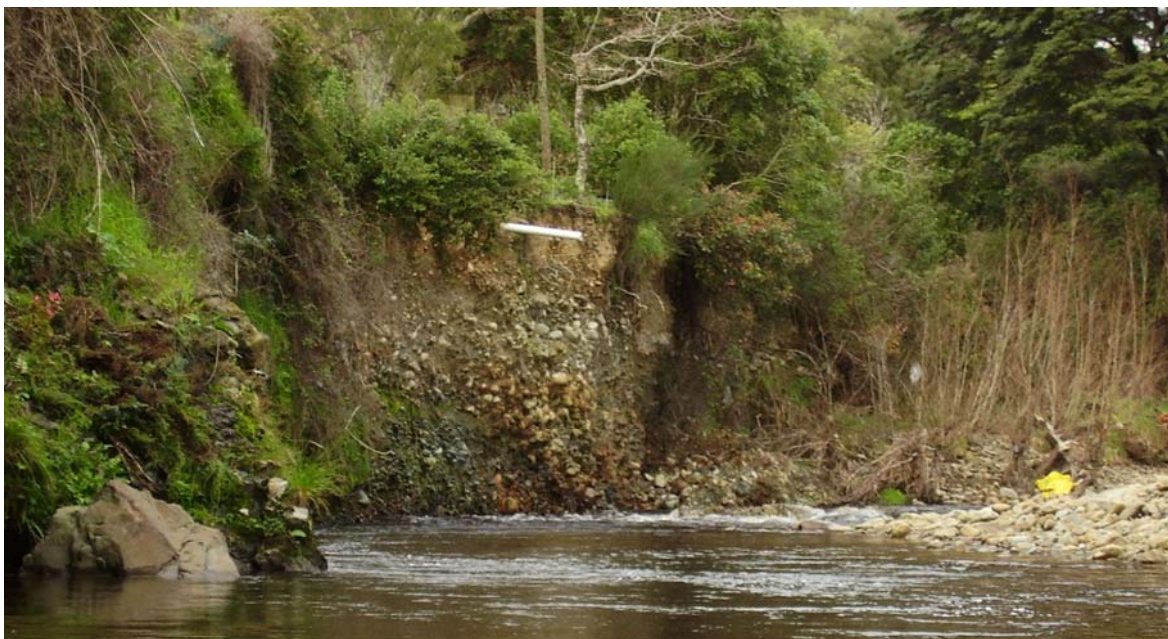
■ **Figure 2 Erosion Hazard Identified Adjacent to Maymorn Road, Areas B and C**

Areas B and C have been classified under the extreme risk category. This section of river, running adjacent to Maymorn Road, is confined by steep banks and has a steeper gradient than much of the upper catchment. The river through this area has relatively higher velocities than those found in the rest of the Mangaroa. These factors contribute to the scour along the banks, see Figure 2.

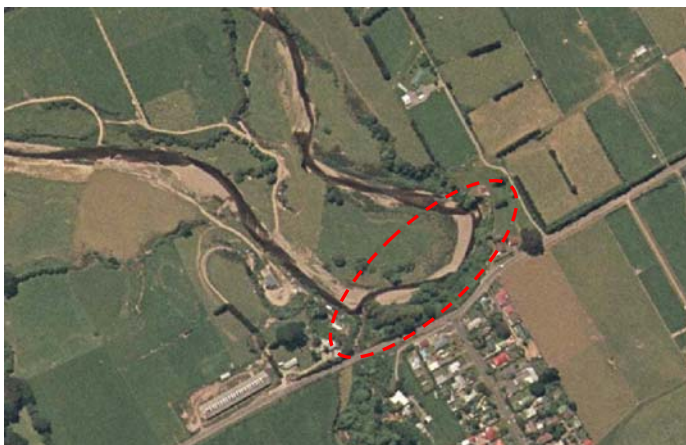
■ **Figure 3 Erosion Hazard Identified Near Parkes Line Road (Area E)**

Area E, adjacent to Parkes Road represents another erosion hazard classified in the extreme category, see Figure 3 and Figure 4. The Maymorn housing area is located on a river terrace 15-20m above the river. The steep banks on the river bend have the potential to slip endangering the infrastructure and properties above.

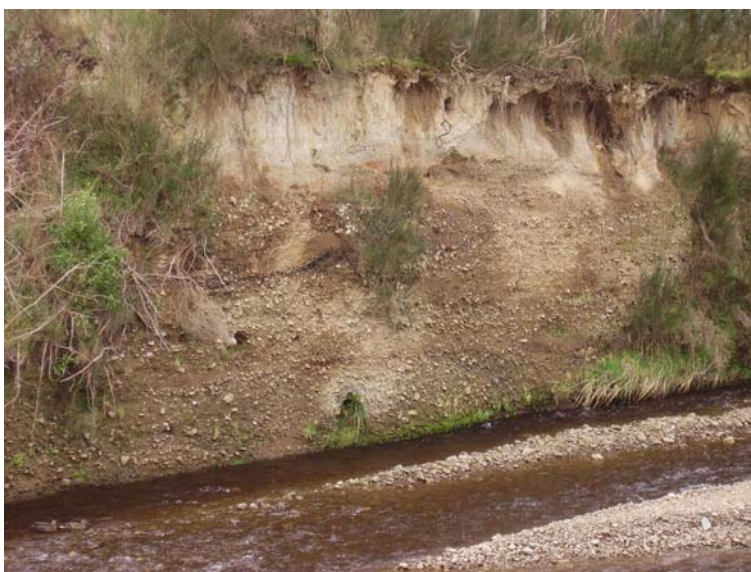
■ **Figure 5 Mangaroa Hill Bridge Erosion Area**

Area I covers 300m of the true right bank upstream of the Mangaroa Hill Road Bridge. This area is also considered to be in the extreme category of erosion risk. Figure 5 depicts the loose alluvial material that the banks consist of.

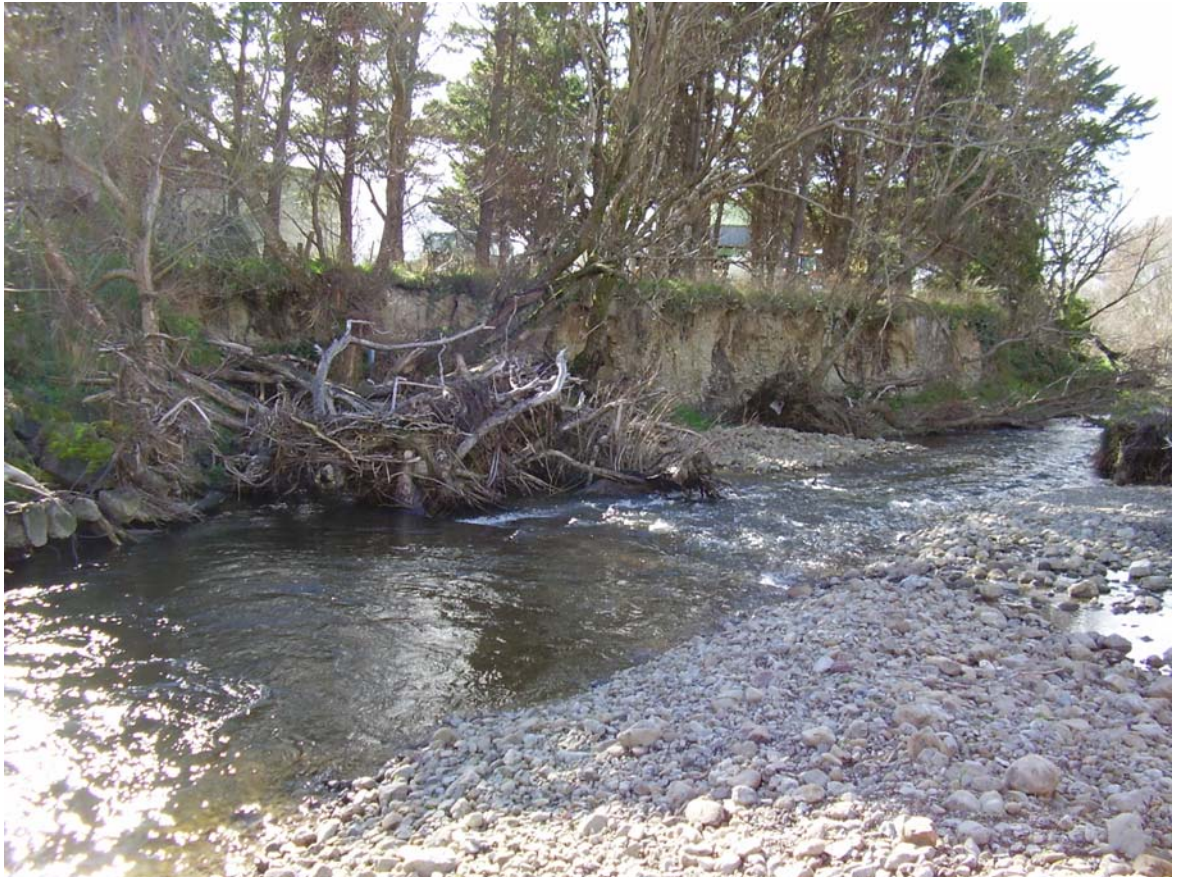
■ **Figure 6 Erosion of the Banks Near Mangaroa Valley Road.**

Areas P and Q surround the Mangaroa Valley Road Bridge. The banks in this area demonstrate evidence of recent erosion. Figure 6 shows the close proximity of buildings to the river. Unchecked erosion in this location has the potential to endanger half a dozen buildings at this location.
